JANUARY 1965

THE NAVAL AVIATION SAFETY REVIEW

## Single-Engine Versus Twin-Engine . . . What Can Happen With A 50 Percent Power Loss

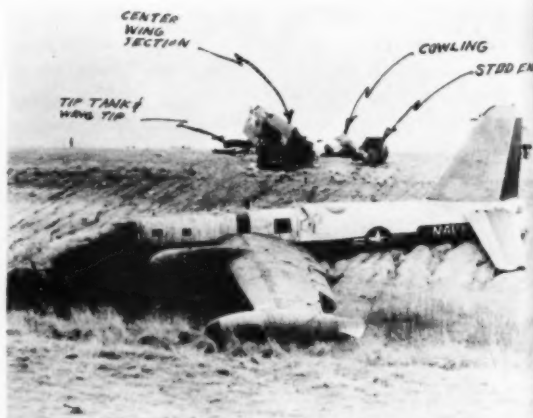
No jets were available to the pilot of this P-2H on a night single-engine approach. Full flaps and low airspeed led to loss of control before the field was made.

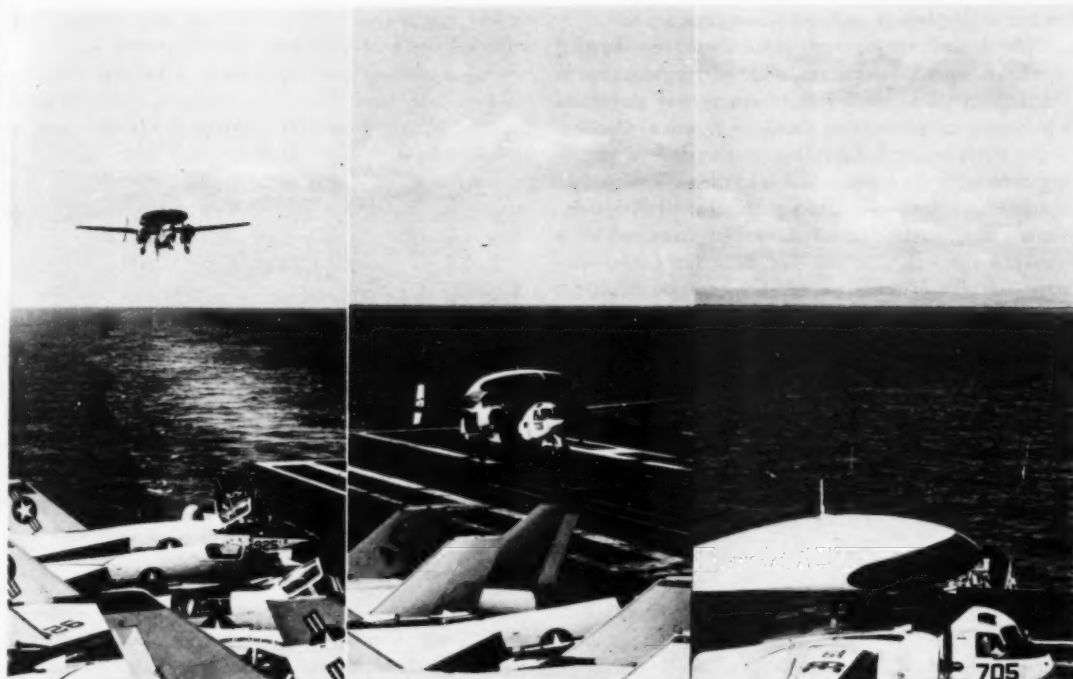
An E-1B of CARAWRON 12 comes aboard USS SARATOGA with one engine caged. Port engine was lost shortly after cat shot. Pilot dumped fuel and with ready deck 10 minutes away, elected to make arrested landing rather than divert. Final approach was with 1/3 flaps and 105-110 knots. No. 1 wire caught.

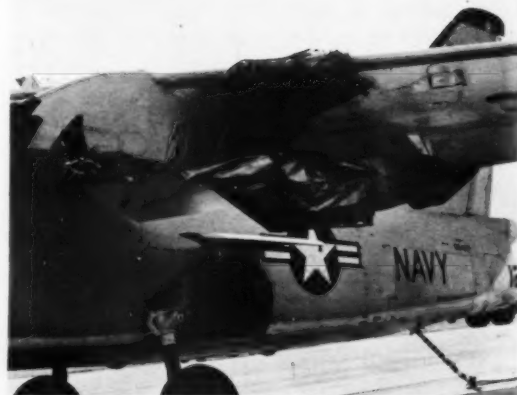
Some pilots have been quite literal when announcing "I've lost an engine." A-3 characteristics were not much affected compared to recips with "flat plate" effect of firewall.

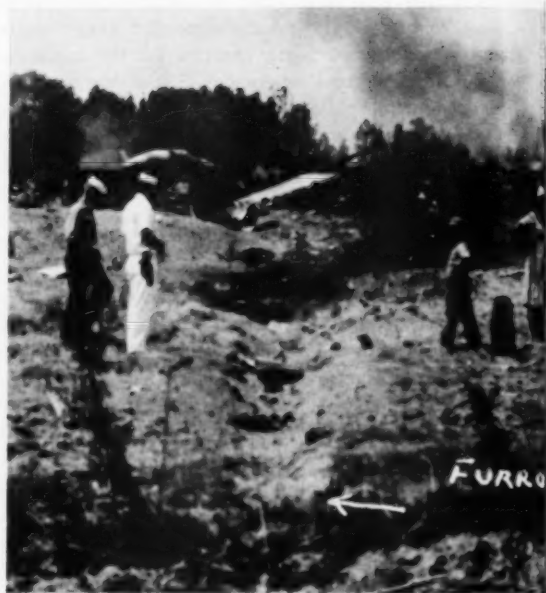
Smoking rubble was once A-6. Crew ejected safely. After single-engine waveoff pilot turned downwind and dropped both gear and flaps. Loss of altitude followed.

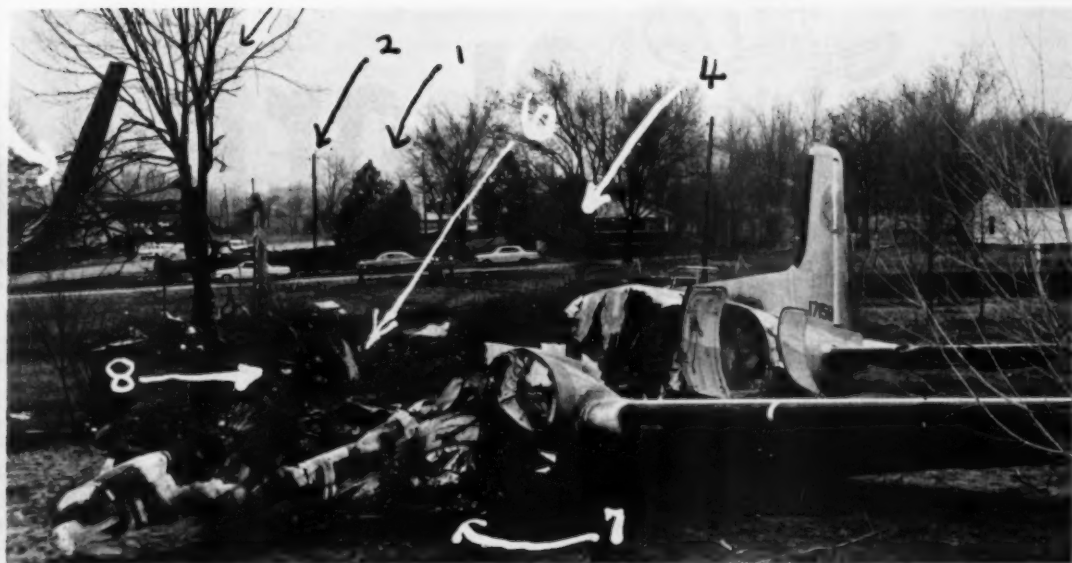
A small broken spring on the landing gear latch is believed to have led to this unsuccessful single-engine waveoff. The right seat pilot brought the flap handle up—but only to the neutral position. His attempts to raise the gear were unsuccessful. C-117 hit with full flaps. Fortunately, no fatalities.

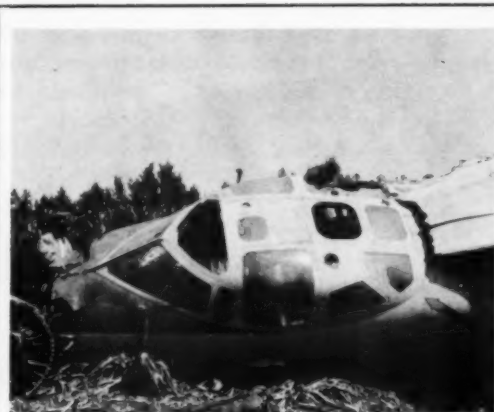
Aircraft touched down in a cornfield at a fairly flat attitude. The relatively intact cockpit indicated that the crash forces were survivable.

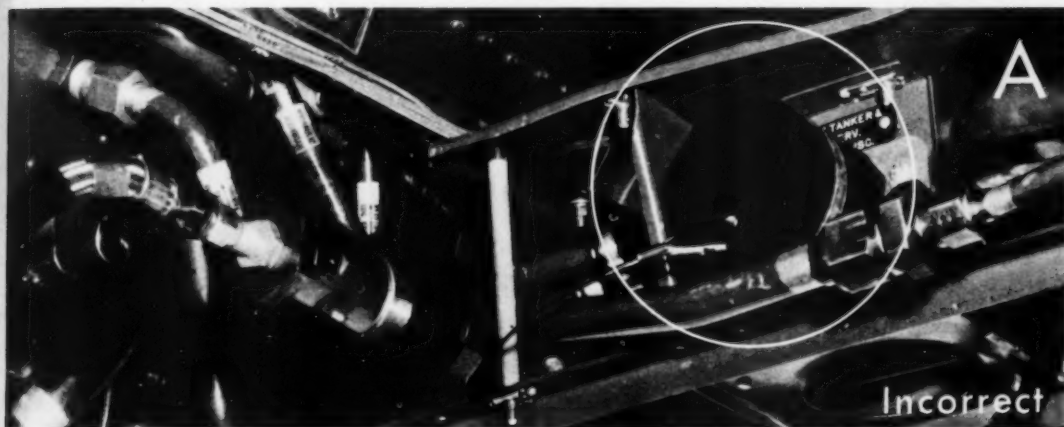
Radar hydraulic line misinstalled in dust cap stowage bracket (circle).

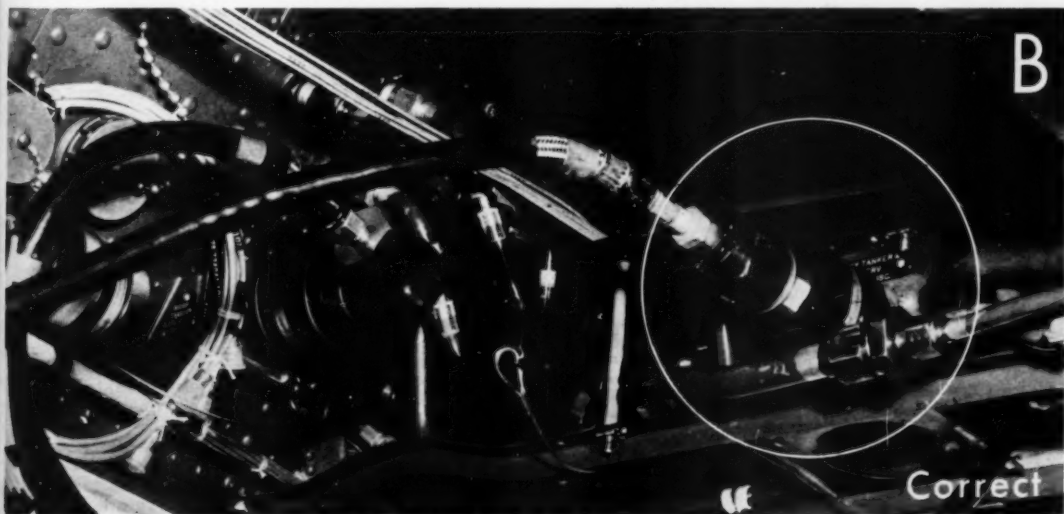
Photo B depicts the proper point of connection of the radar hydraulic system return line located in the bomb bay.
